Beautiful as Nefertiti

Architectural concrete precast elements for the New Museum in Berlin

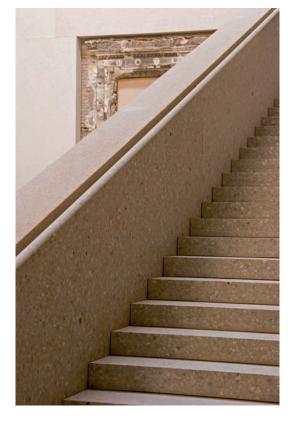
Ground hand rail in the main staircase

In total, $1,950 \, \text{m}^3$ of marble concrete were manufactured, $5,300 \, \text{m}^2$ of concrete surface were ground and $11,250 \, \text{m}^2$ sand-blasted. Particularly worthy of a mention are the columns of up to 15 m in length with a square cross-section and an edge length of 50 cm, which were blasted on all four sides, and the handrails of the stairs, which were ground to a round form using a diamond form miller.

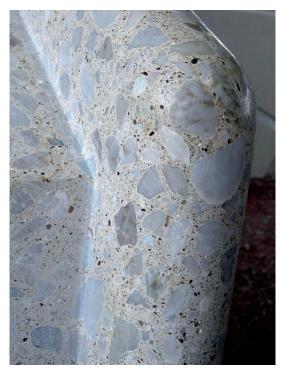
Detailed view of the ground hand rail

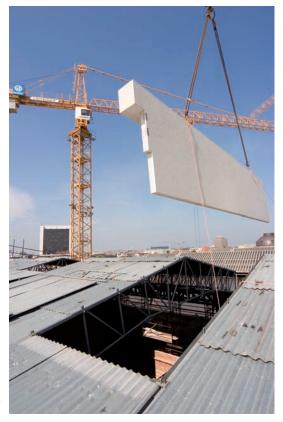
Lifting a precast element through the open temporary protective roof

assembly were avoided as a result. Closed transport vehicles were used for the most part in order to avoid the elements becoming dirty during transport from the precast factory to Berlin. Great care was also called for in securing the individual high value concrete elements for transport. Assembly was mainly performed by tower cranes, whereby the variable protective roof in the area of the existing building had to be opened for each individual lifting operation. In the basement, the precast elements were brought to the place of installation by means of elaborate transfer inside the building. Extensive measures were taken to protect the concrete surfaces, which were actually the final surfaces even in the raw building state, such as rear-ventilated wooden formwork or galvanised connecting reinforcements.

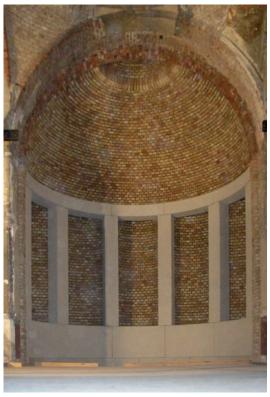
Interior view of the apse in the Greek Courtyard

Of the two inner courtyards, the Greek Courtyard was very well preserved, apart from the destroyed apse. In the lower wall area, a new sand-blasted wall of marble concrete was placed in front all round. The apse was built up again in the upper area using old bricks. The so-called Egyptian Courtyard in particular has been given a new interiority through the use of architectural concrete elements. Contrary to the condition before the destruction, new exhibition rooms were added on three floors, supported by a system of columns and covered by a glass roof. The design envisaged four-sided, sandblasted, 15 metre high 50/50 columns for this support system. At the same time, the intersections of the precast element construction had to be formed in such a way that the observer does not perceive the individual elements and assumes a continuous, monolithic node. All visible concrete surfaces are sandblasted here also.

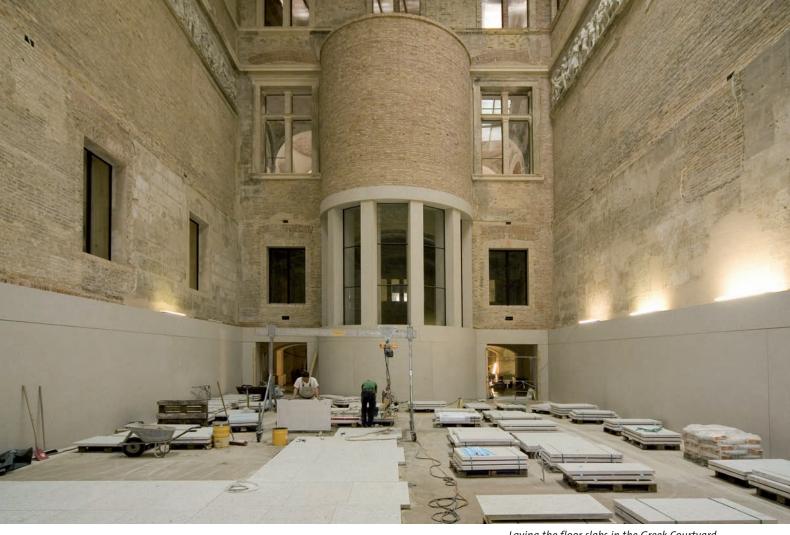
Laying the floor slabs in the Greek Courtyard with its distinctive apse

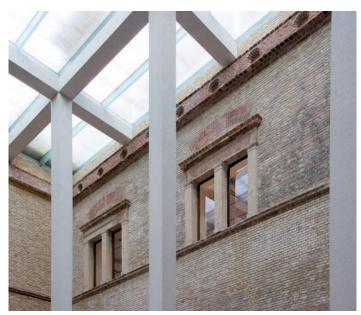
Precast columns with grating on the glass roof level of the Egyptian Courtyard

For their manufacturing, the columns were concreted in a recumbent position with a cross-section of 55/50. Following the initial curing process, five centimetres were removed from the pouring side in order to achieve the final cross-section of 50×50 cm. The high rigidity of the concrete was decisive for this. Thanks to this unusual method it was possible to give all sides of the columns a similar appearance by means of four-sided sand-blasting.

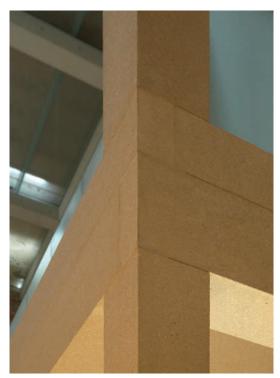
Corner intersection of the precast construction in the Egyptian Courtyard

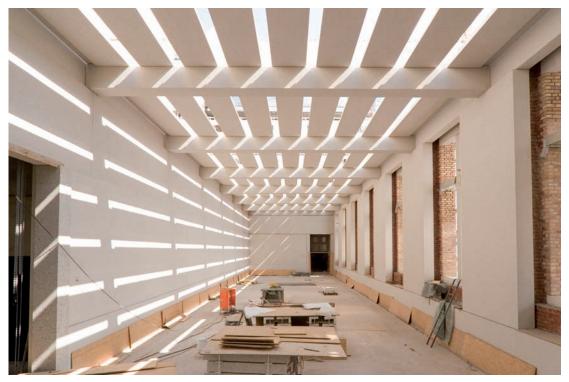
Rolling ceiling in the assembled condition without upper ceiling and with still open intermediate spaces

engineering systems in addition to a sand-blasted suspended ceiling and to construct the supporting castin-situ ceiling above that, the 'rolling ceiling' was invented as a solution. To this end, the supporting joists were mounted first, sand-blasted, in the lower visible area. The self-supporting suspended ceiling elements, made of marble concrete, were subsequently

placed at distances on the console of the joists. These ceiling slabs are provided with rollers at the support points and can thus be slid easily. Finally, precast slabs were placed on the joists and the supporting ceiling concrete was poured. In order to install the building service engineering systems, the suspended ceiling elements were simply pushed together and separated again after installation was complete. The lighting units are situated between the ceiling slabs. The remaining intermediate space is either filled with two centimetre thick sand-blasted concrete slabs or serves as an empty space for the installation of lighting units and other built-in technical equipment.

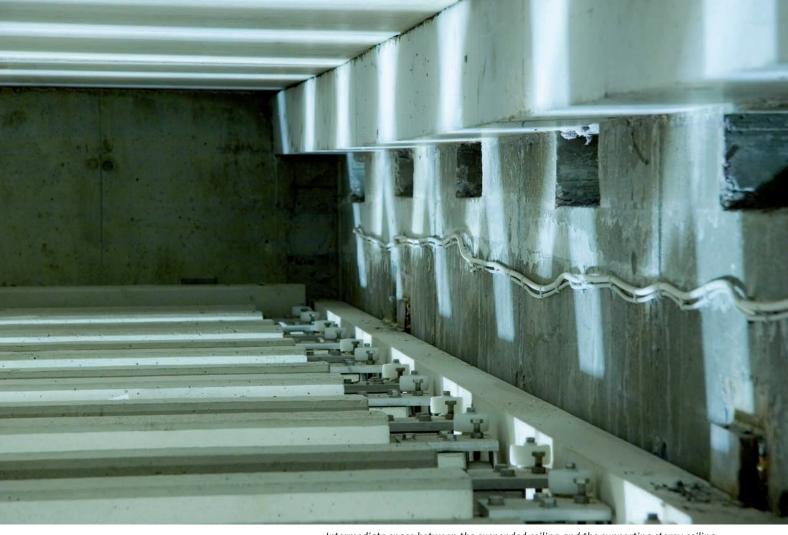
Intermediate space between the suspended ceiling and the supporting storey ceiling
